# Contractors Solves Storm Drain Problem in Georgia

When Robins Air Force Base in Warner Robins, GA, set out to build an 80,000 square-foot depot plant services facility they knew they faced a number of challenges. Not only is land at a premium on the busy military base, the building site selected was situated directly over an aging large diameter storm sewer.

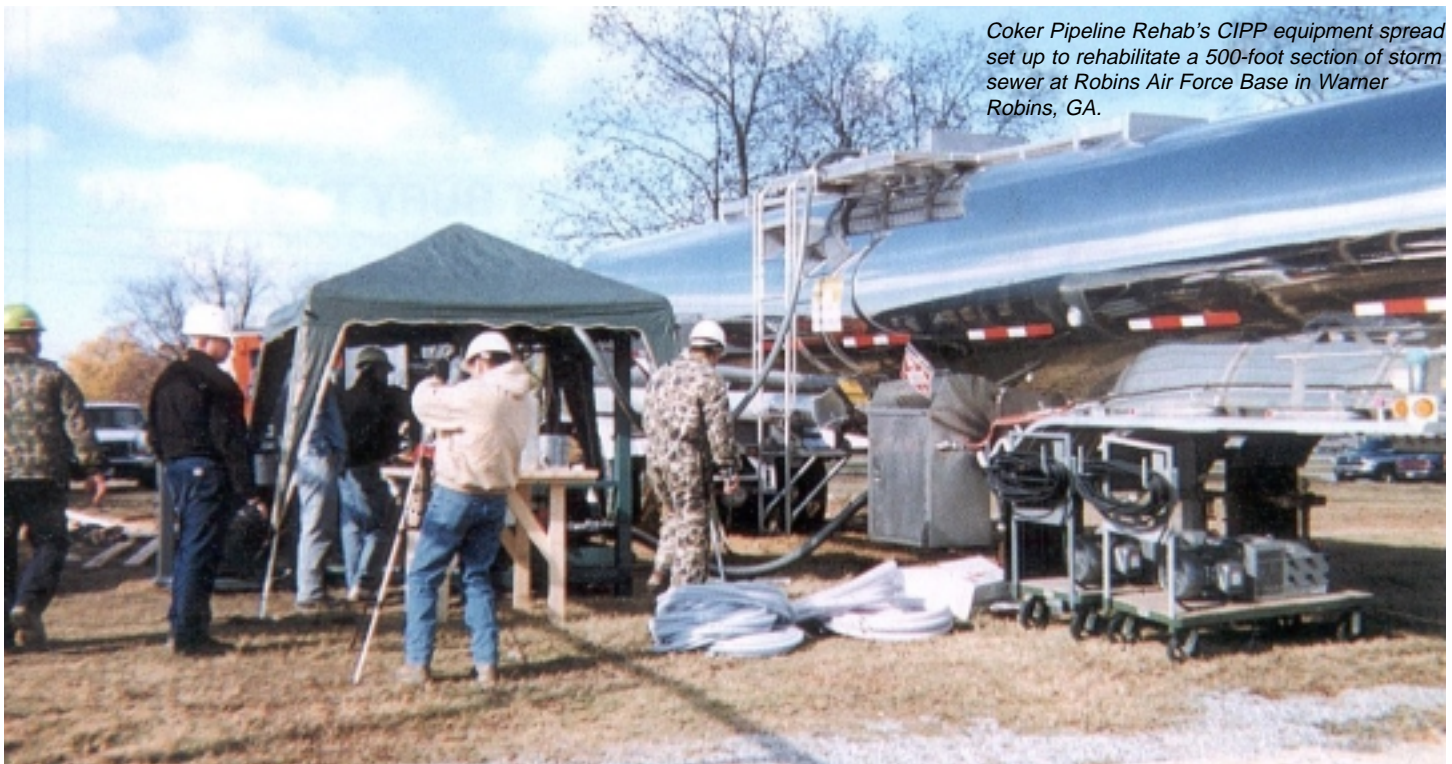
*Coker Pipeline Rehab's CIPP equipment spread set up to rehabilitate a 500-foot section of storm sewer at Robins Air Force Base in Warner Robins, GA.*

The conveyor, leased from NJR Industries, Mobile, AL, and capable of handling 48- to 120-inch liner products, is among the largest available in the U.S. Other major equipment items included two boiler trucks manufactured and purchased from Rush Sales of Odessa, TX.

During early evaluations, Coker had determined that the CIPP installation could be accomplished by working from just two manholes. At the location where the liner installation was to take place, crews remove the chimney portion of the manhole and

installed a trench box to provide sufficient space for the conveyor to be set up and lower the liner into host pipe. At the second location, crews were able to gain access without removing the inside of the manhole or carrying out any excavation.

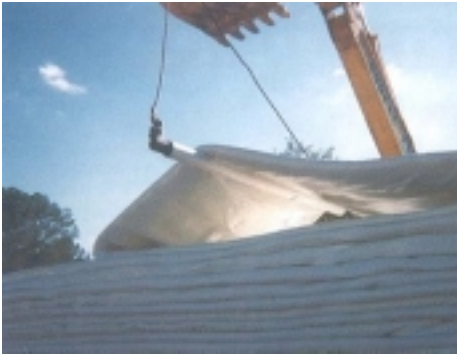
*A trackhoe was used to lift the heavy liner to relieve stress during the inversion process.*

Leckie said the installation process starts with the felt fabric being impregnated with a heat sensitive resin. Next, the inversion tube is filled with water. The pressure of the water pushes the liner into the host pipe and turns it inside out, forcing the heat sensitive fabric against the walls of the host pipe.

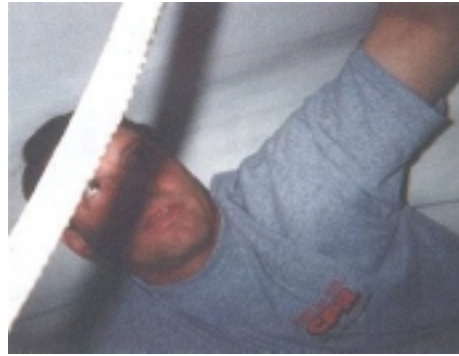
*Kerry Coker examines ropes inside the liner to assist with installation.*

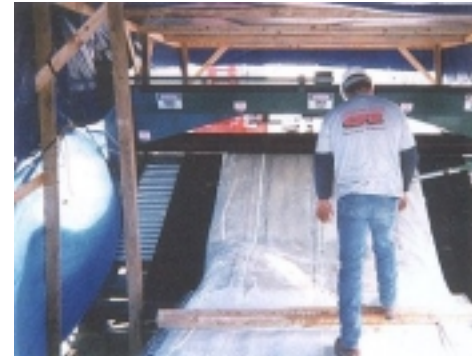
*Resin is shown being introduced into the liner.*

After the fabric is inserted to the specified length, water is circulated through a boiler. The hot water activates the heat sensitive resin causing it to cure within a matter of hours. Once completed, the pipe is inspected and tested.

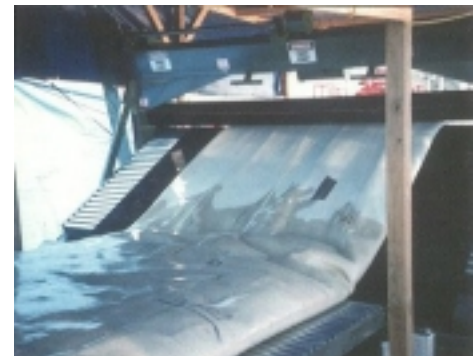
*Resin is visible as the felt becomes saturated.*
